October 18, 2001

SUBJECT: COMPLETION OF STAFF REVIEWS OF NRC BULLETIN 96-03,  
"POTENTIAL PLUGGING OF EMERGENCY CORE COOLING  
SUCTION STRAINERS BY DEBRIS IN BOILING-WATER REACTORS,"  
AND NRC BULLETIN 95-02, "UNEXPECTED CLOGGING OF A  
RESIDUAL HEAT REMOVAL (RHR) PUMP STRAINER WHILE  
OPERATING IN SUPPRESSION POOL COOLING MODE" (TAC  
NUMBER MA0704)

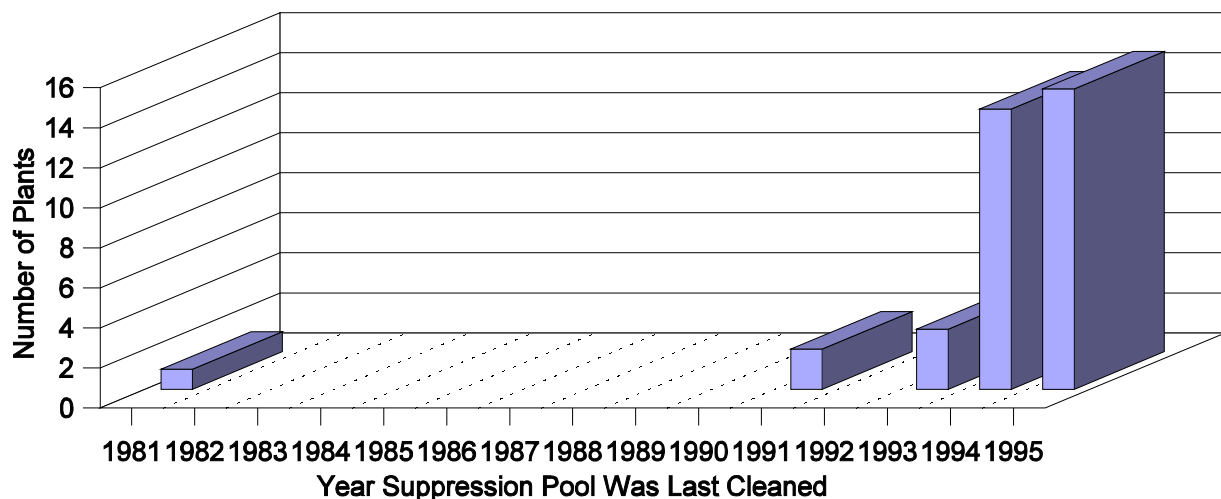
**Figure 1: NRCB 95-02 Responses on Last Suppression Pool Cleaning**

Addressees were requested to respond to the NRCB 95-02 within 30 days. We received responses for 37 BWRs. The Containment Systems and Severe Accident Branch (SCSB) performed an initial screening of all responses. Figure 1 summarizes the bulletin responses as to when licensees had last cleaned their suppression pools (as of the date of their initial responses to NRCB 95-02).

Figure 1 clearly shows that BWR licensees had, in fact, been cleaning their suppression pools. One exception was Nine Mile Point, Unit 1 (NMP-1). Figure 1 does not include Big Rock Point because their design does not have a suppression pool, and Browns Ferry, Unit 1, who was in an extended shutdown at the time of their response. Tennessee Valley Authority (TVA), the licensee for Browns Ferry, stated in their response that they would address the bulletin issues for Unit 1 before restarting the plant.
